## ANTARES CHARTS CORRECTIONS AND CAUTIONS 2021

Our current set of charts is **Antares Charts 2020** (there will be no 2021 set): the following **Corrections** and **Cautions** relate to issues identified after its publication. Corrections will be reflected in our next set of charts, expected to be published in January 2022. All Corrections and Cautions are subject to the Conditions posted on this website.

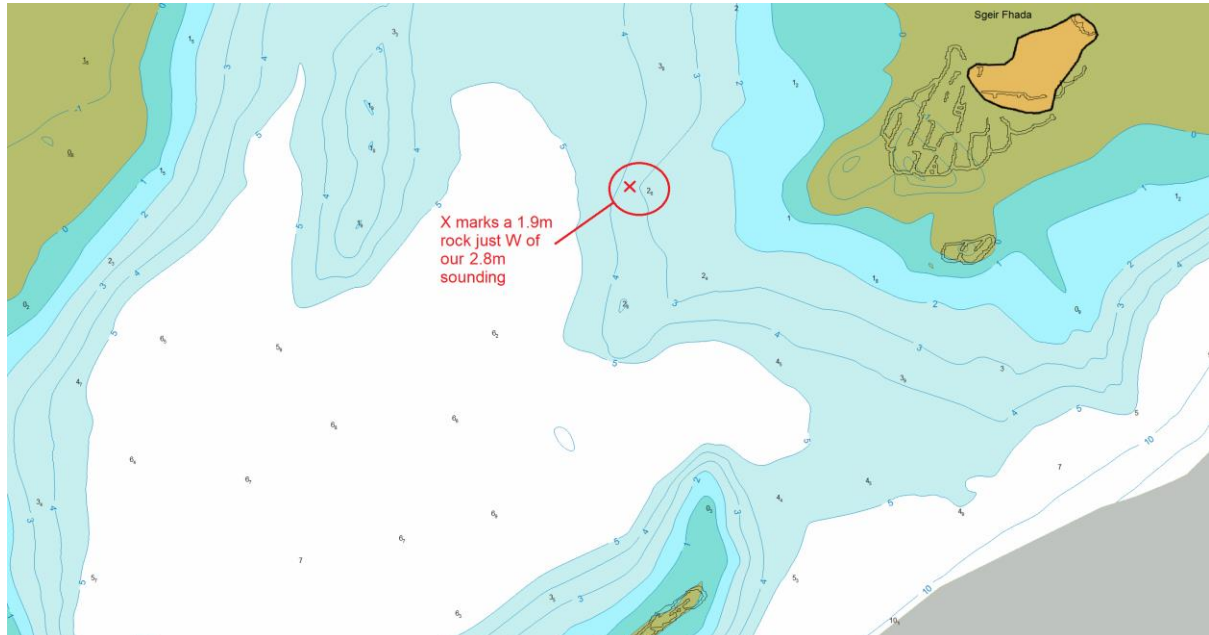
**April 2020 and June 2021: Correction to a correction!: Chart 5724A, edition 2, Lochcarron Bay:** a professional survey in early 2020 reported a 1.9m rock in an area we show as over 3m and close to a 2.8m sounding. The position is 57deg 23.78N, 5deg 28.95W. See extract from our chart, below. We reported this as a correction in April 2020. In June 2021 we re-surveyed the area to find no trace of the reported rock. The UKHO has been notified.

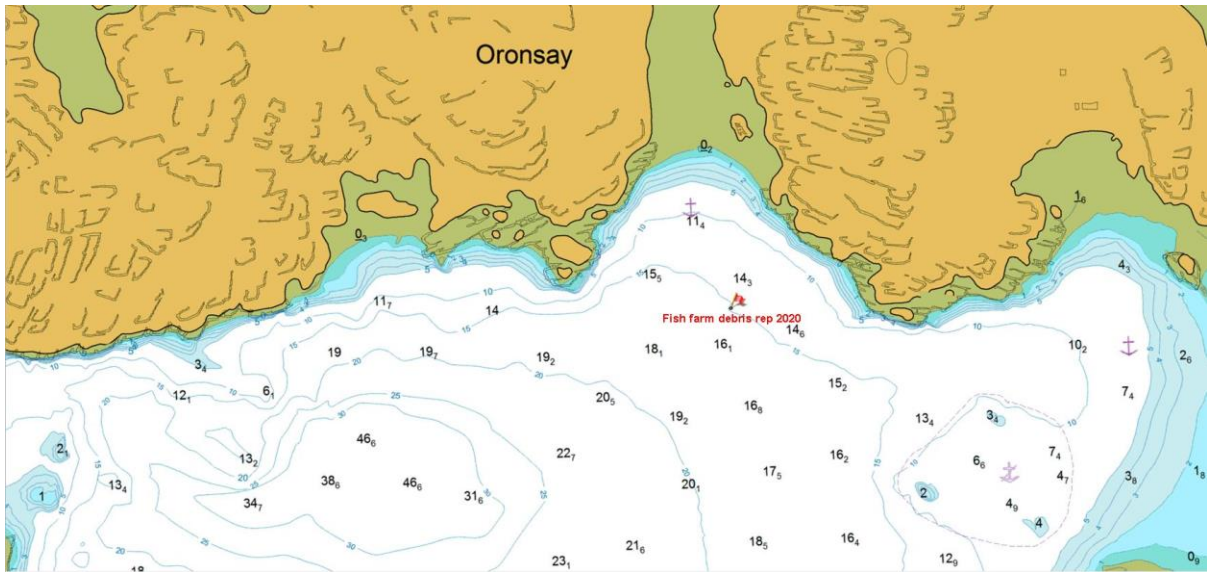
**August 2020: New hazard: Loch Drumbuie:** an Antares Charts subscriber recently reported the following serious underwater hazard: a heavy pile of fish farm debris comprising nets, steel poles and ropes - all well enough secured to the bottom to hold our vessel on a vertical rode against 30knots! Location, roughly on the 15m

contour to the north of the Loch: 56° 39.428' N 5° 55.733' W. For convenience this position is shown on the extract of our chart:

**Please note** that we do not expect to be able to detect obstructions of this sort – we can only mark them when they are reported to us. And we seldom show floating fishing gear as it tends to be moved quite frequently

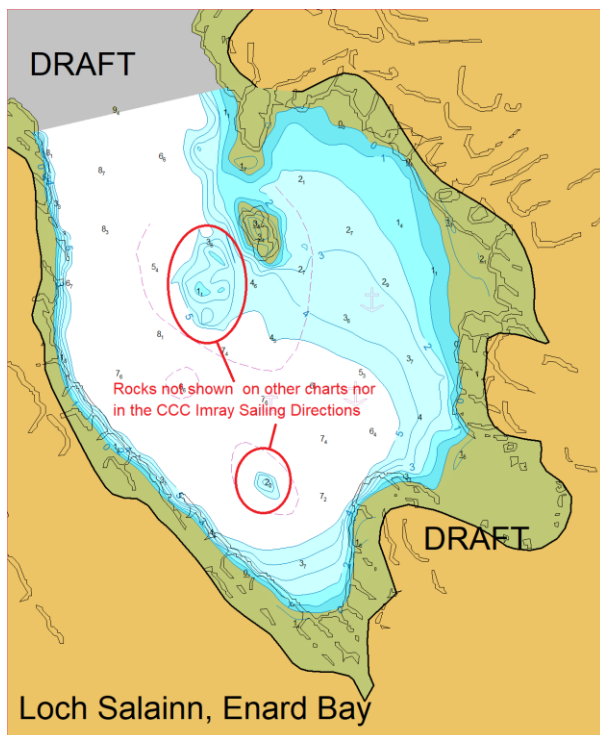
**June 2021: Caution: Loch Salainn, Enard Bay.** There is a large rocky area with least depth of 1.1m adjacent to the prominent drying rock and partly obstructing the channel into the loch. There is also a rock with least depth of 2.2m exactly where yachts would be likely to anchor. An image of a draft chart is reproduced below.
