ANTARES CHARTS CORRECTIONS AND CAUTIONS 2026

Our current set of charts is **Antares Charts 2026:** the following **Corrections** and **Cautions** relate to issues identified after its publication. Corrections will be reflected in our next set of charts, expected to be published in January 2027. All Corrections and Cautions are subject to the Conditions posted on this website.

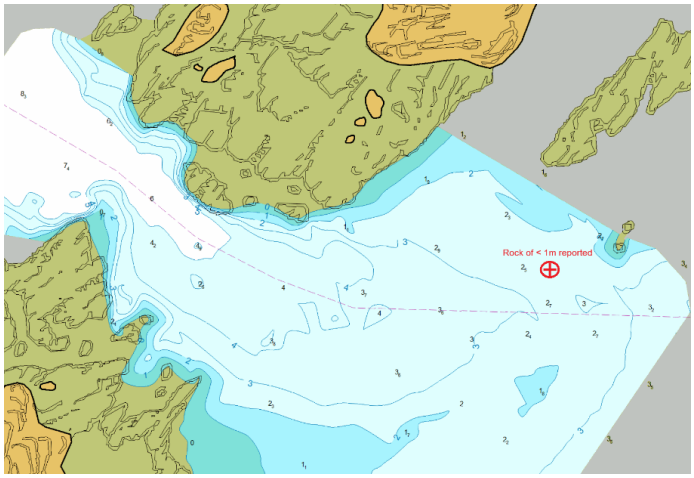
Correction: AC 5621D CaolasAnnraidh, Sound of Iona We received a report of an unmarked rock of less than 1m depth to the NE of the channel. as shown in red on the chart below. We have since confirmed its presence (0.8m) and will publish an updated chart in 2027.

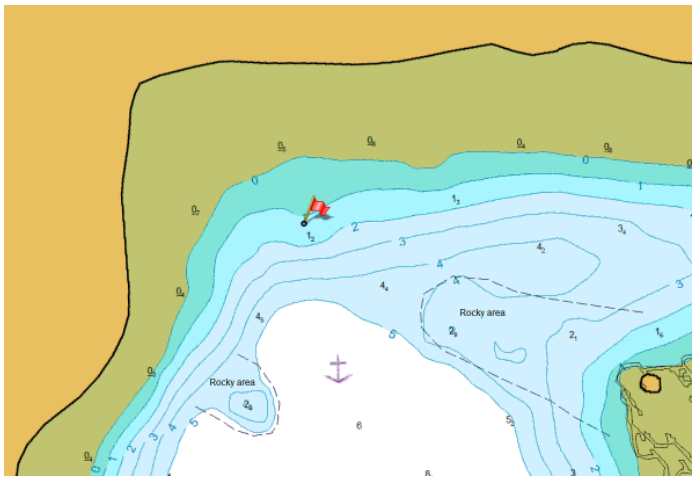
Correction: AC 5624C NE Anchorage, Loch Spelve. We received a report of an uncharted shoal area close to the LW line to the N of our chart. We have confirmed that there is an area of 0.1m just outside our 1m contour as indicated by the red flag on the chart below. An updated chart will be published in 2027
